AC313U / AC330U

MC7700 / MC7710

SWI9200X_03.05.20.03

Release Notes & Upgrading Instructions

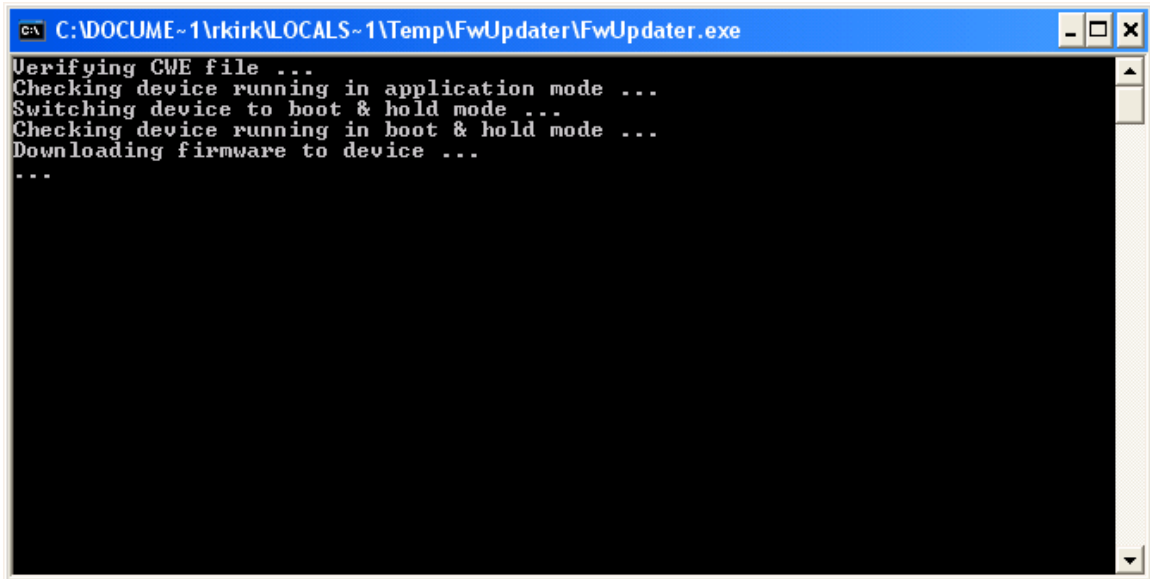
3. When FwUpdater tool starts you will see the following image:

NOTE: The download can take up to 5 minutes to complete. Do not remove the power to either the laptop or the card until the upgrade tool completes.
